The birth of an innovative solution for oil pumping

The first field test of BlueRod™ premium sucker rods successfully reduced well interventions in a YPF field. After operating during the last three years, no failures have been registered.

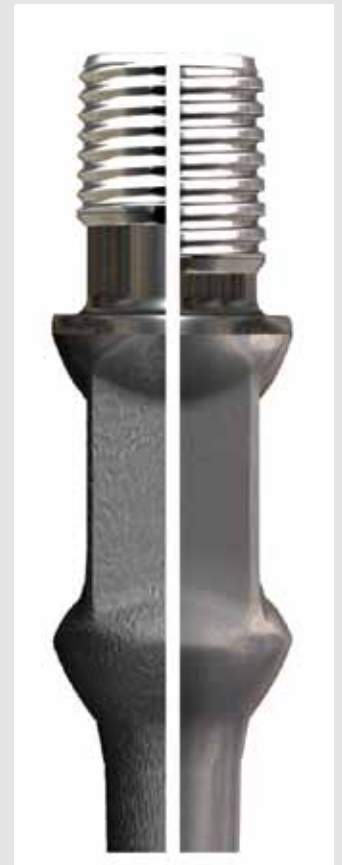
▲ Conventional sucker rod ▲ BlueRod™ premium sucker rod

The connection design offers a significant reduction in stress concentration and plastic deformations, thus reducing the probability of failures produced by fatigue. Also, the flank-to-flank contact reduces the thread's tendency to loosen.

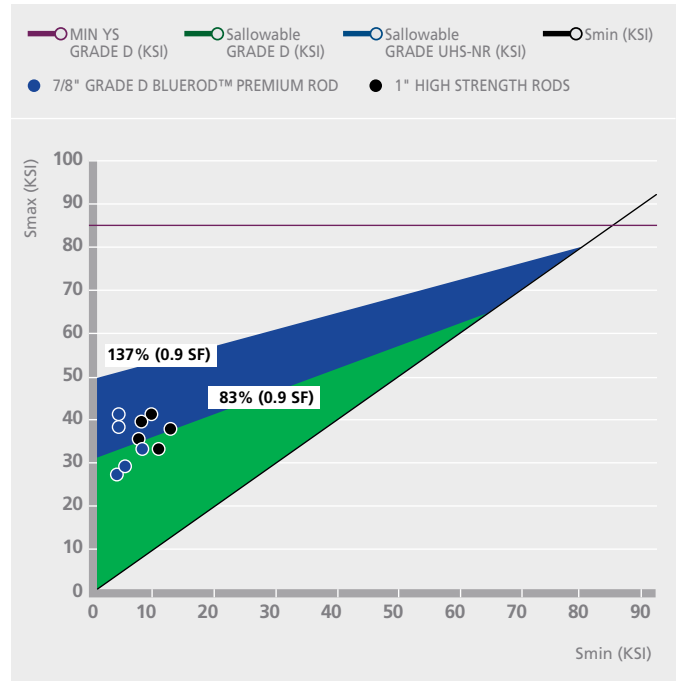
MODIFIED GOODMAN DIAGRAM FOR GRADES D AND HIGH STRENGTH

▲ The chart shows 7/8" grade D BlueRod™ premium sucker rods working under similar stress conditions to those of 1" high-strength rods with conventional connections.

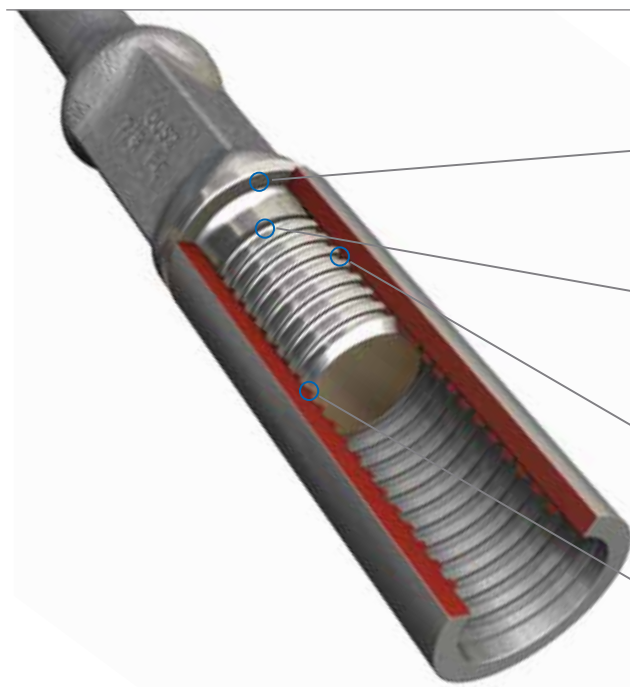
Advantages provided by BlueRod™ premium sucker rods

Stress reduction
A more even stress distribution.
-

Reduction of thread deformation
-

Flank-to-flank contact
Reduces the thread's tendency to loosen.
-

Diametrical interference
Increases the working capacity by decreasing the necessary pre-tension in the pin make-up.
